# Building a Beaver Deceiver - Peterson Pond

This narrative presents an example of an engineered solution to living with beavers in King County. In it we describe the design and installation of a “beaver deceiver” at Peterson Pond in King County, Washington.

# Description of the Stormwater Control Facility at Peterson Pond

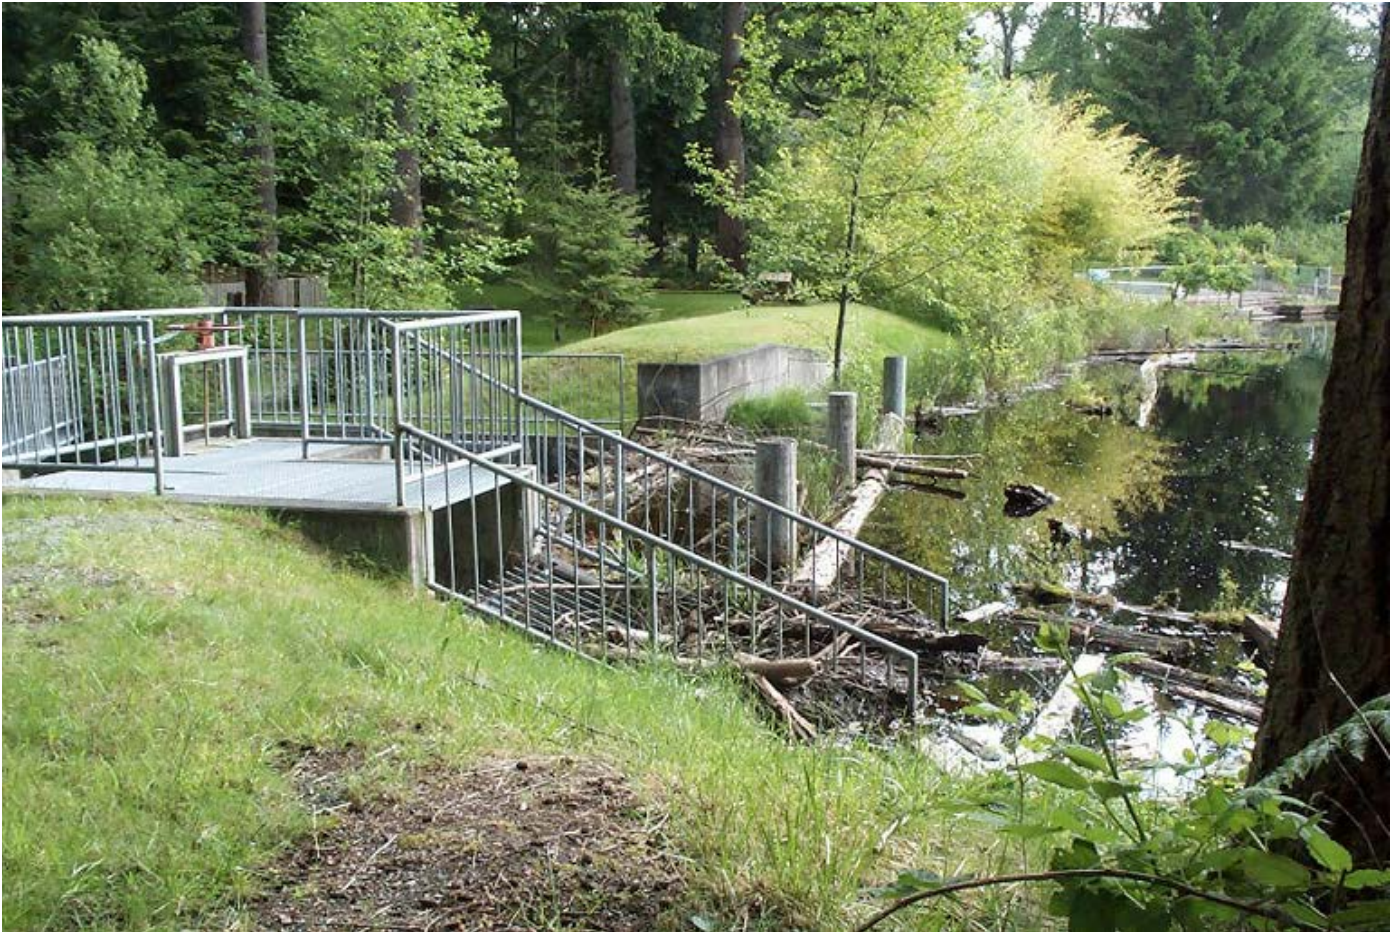
Trash rack blocked by beaver activity.

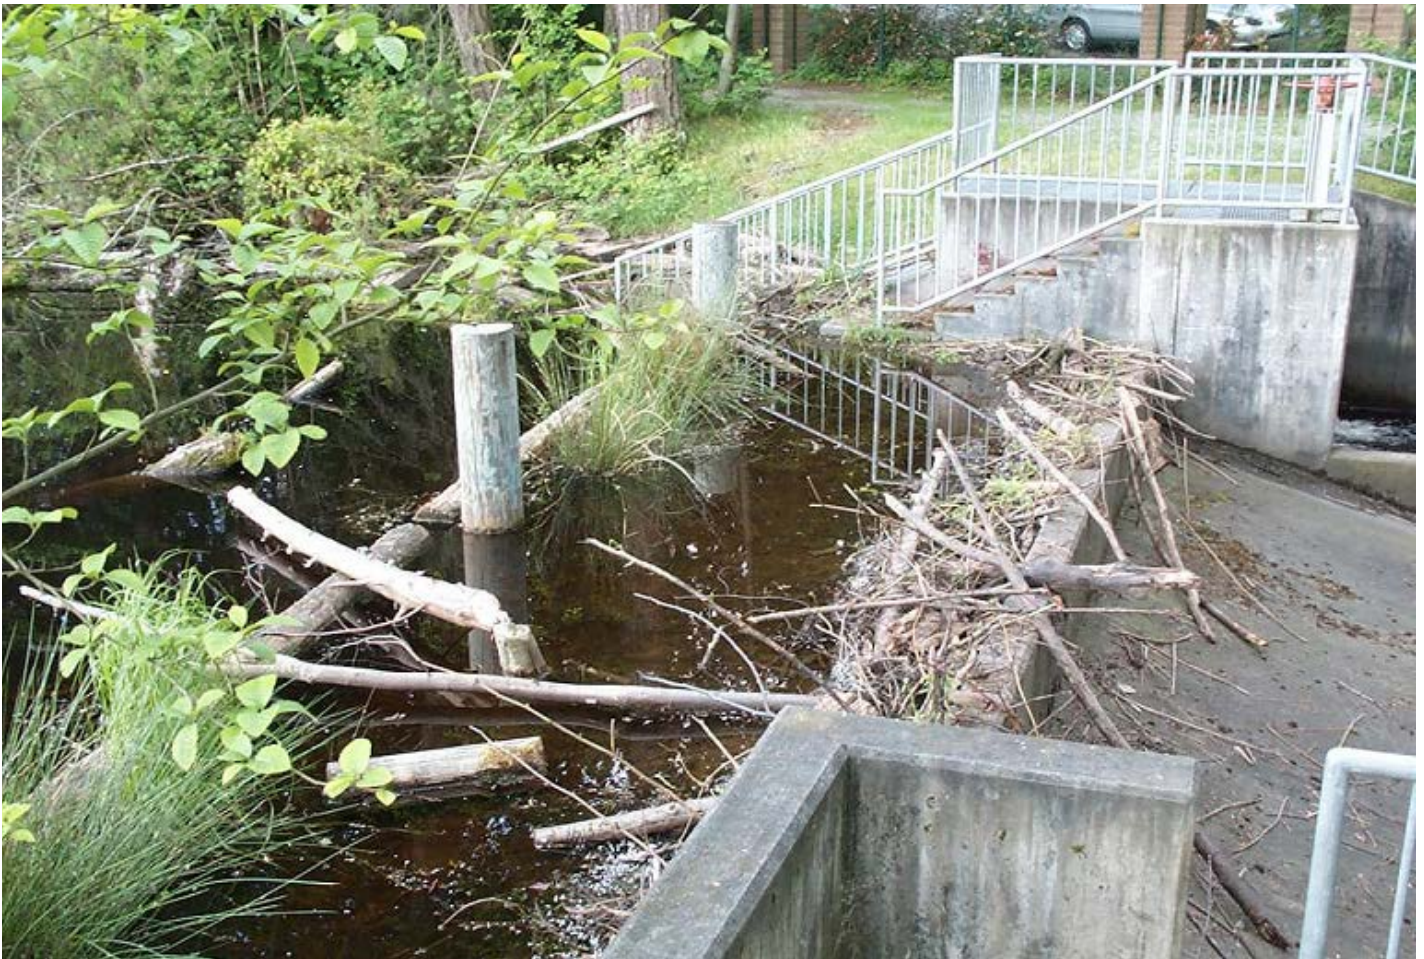
**More beaver activity.**

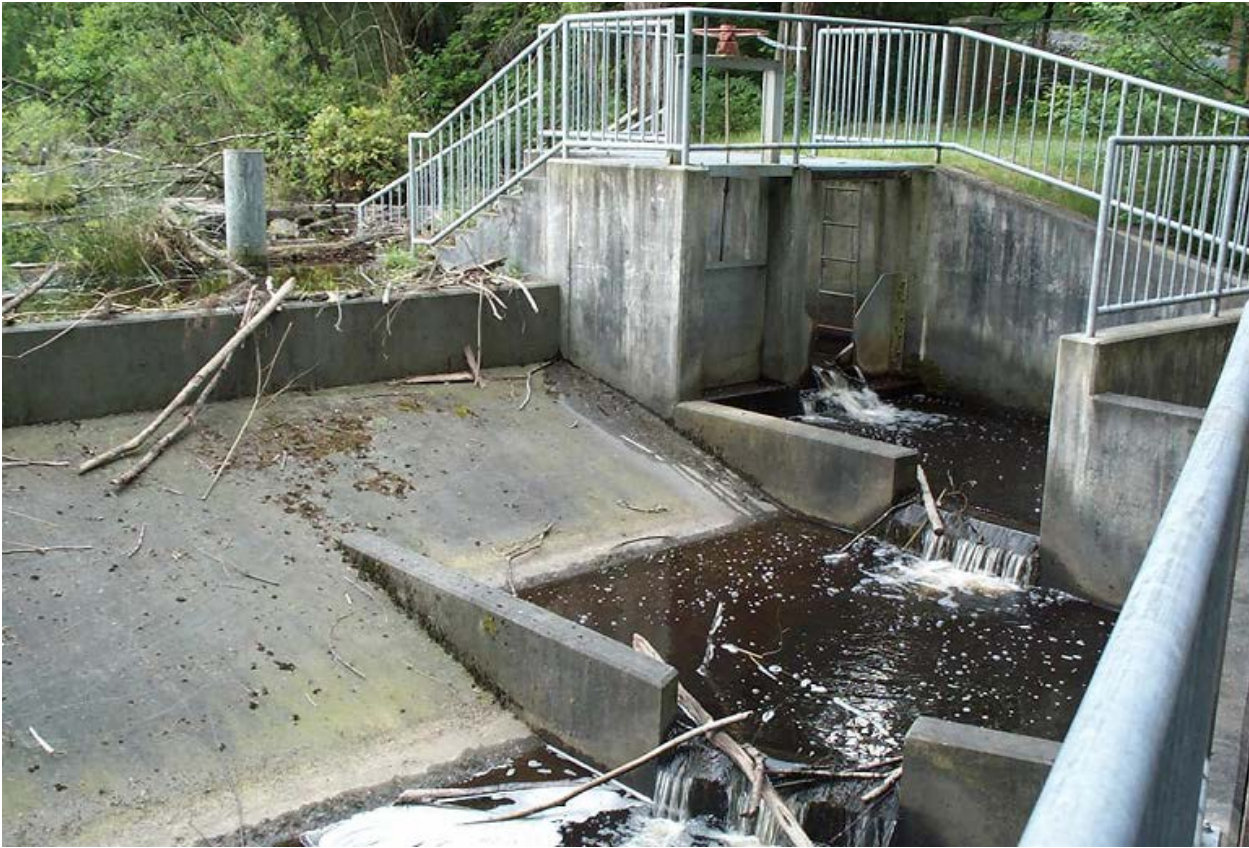
The upstream end of the fish ladder/outlet control structure

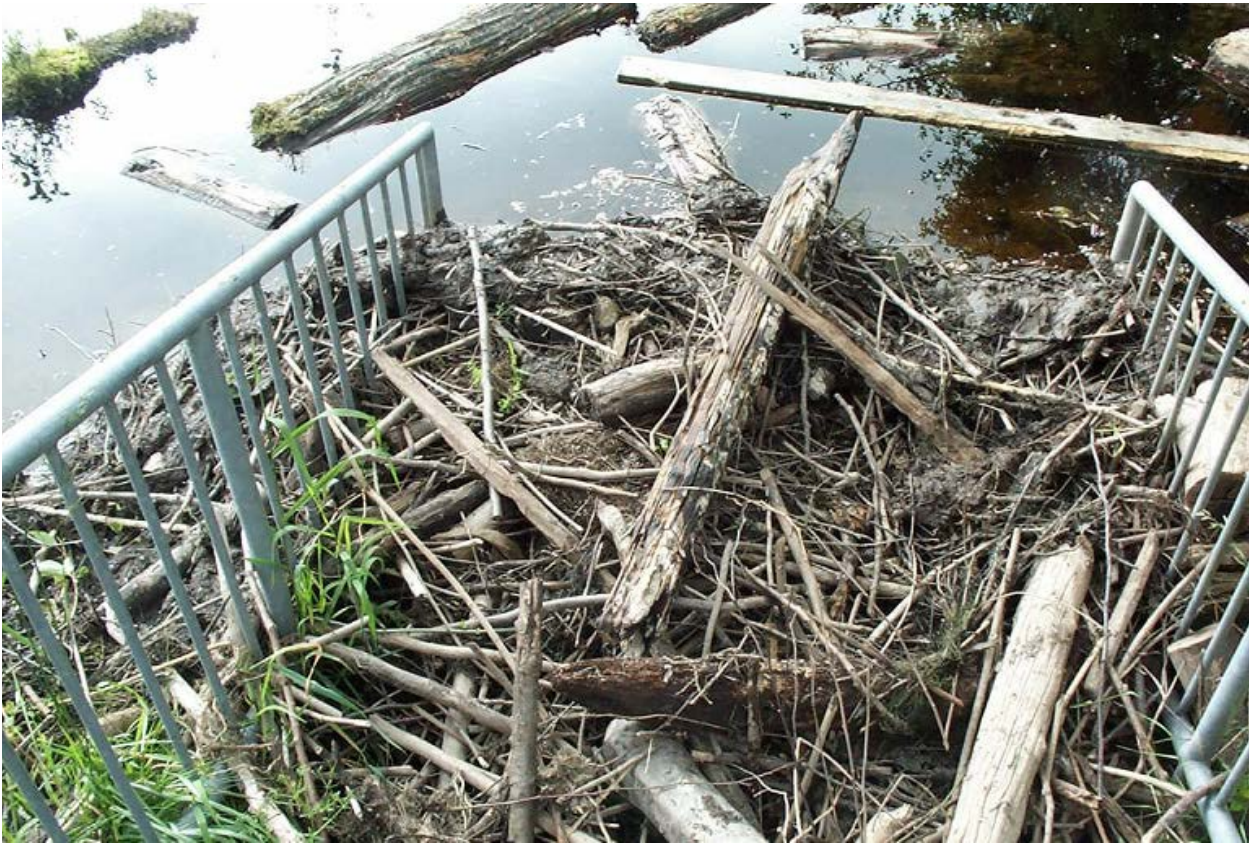
Beaver dam at the trash rack showing woody debris and mud

The beaver dam, woody debris, and mud were removed from the trash rack before installing the beaver deceiver. The dam was removed a couple of days prior to the scheduled installation day to allow the water level in the pond to drop to normal levels. Because the water depth at Peterson Pond was relatively deep for this type of device, decreasing the water level helped with the installation. However, the pond was not drained, and some work was done from small boats.

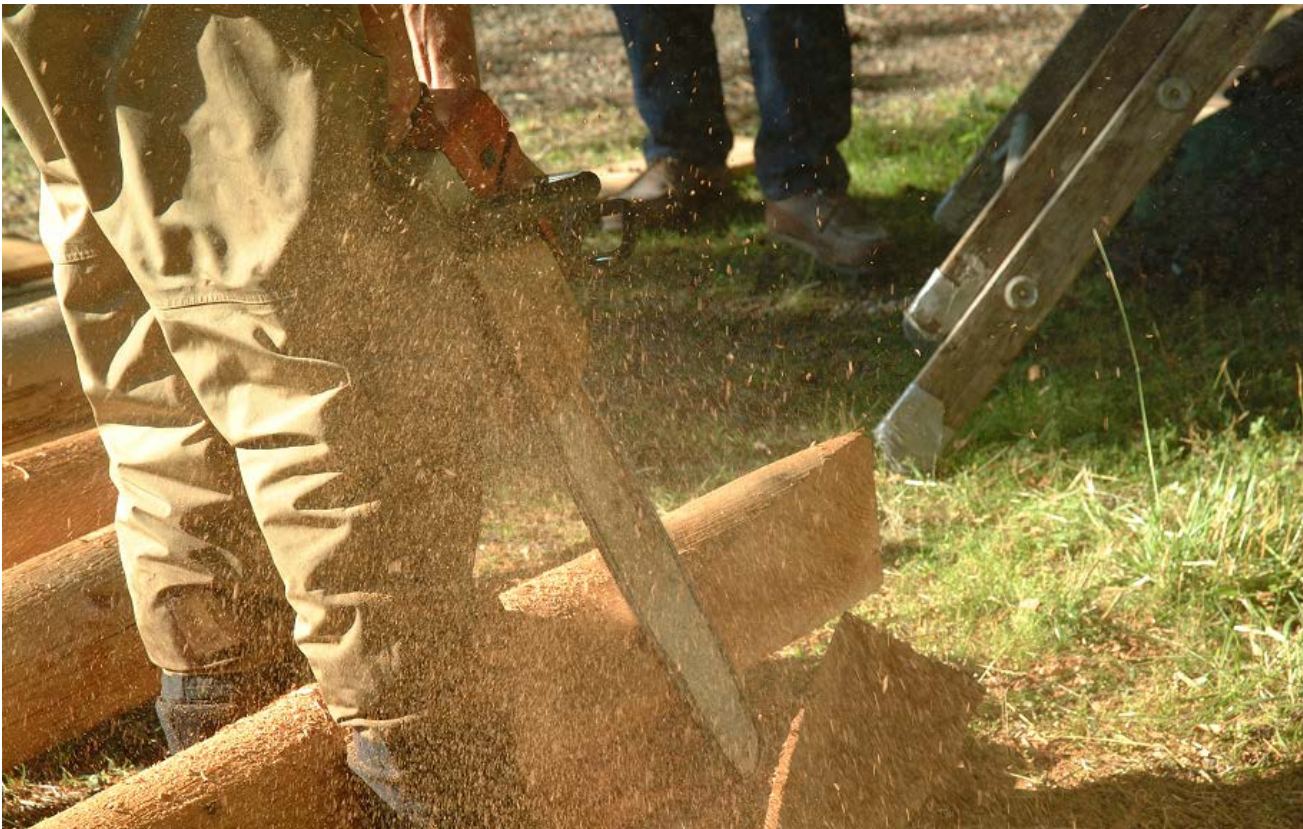
**Cutting points on the corner posts makes it easier to pound them into the substrate.**

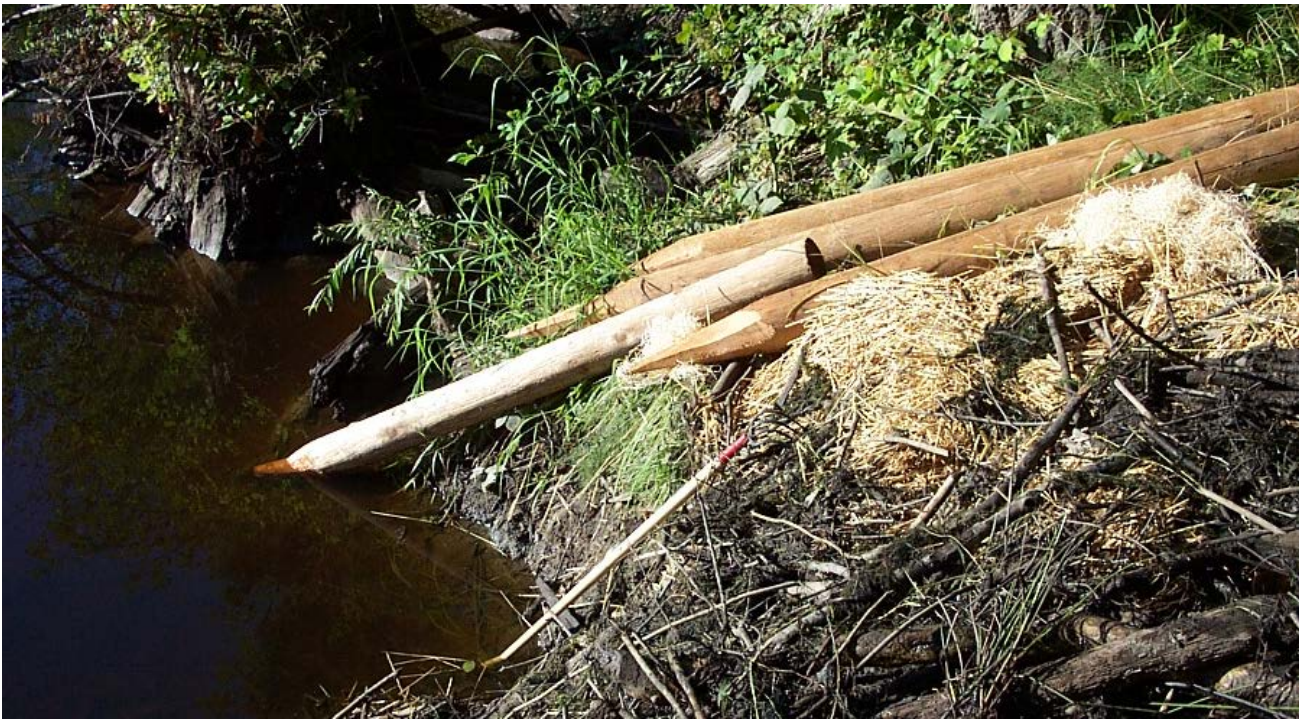
Sharpened corner posts at the water's edge.

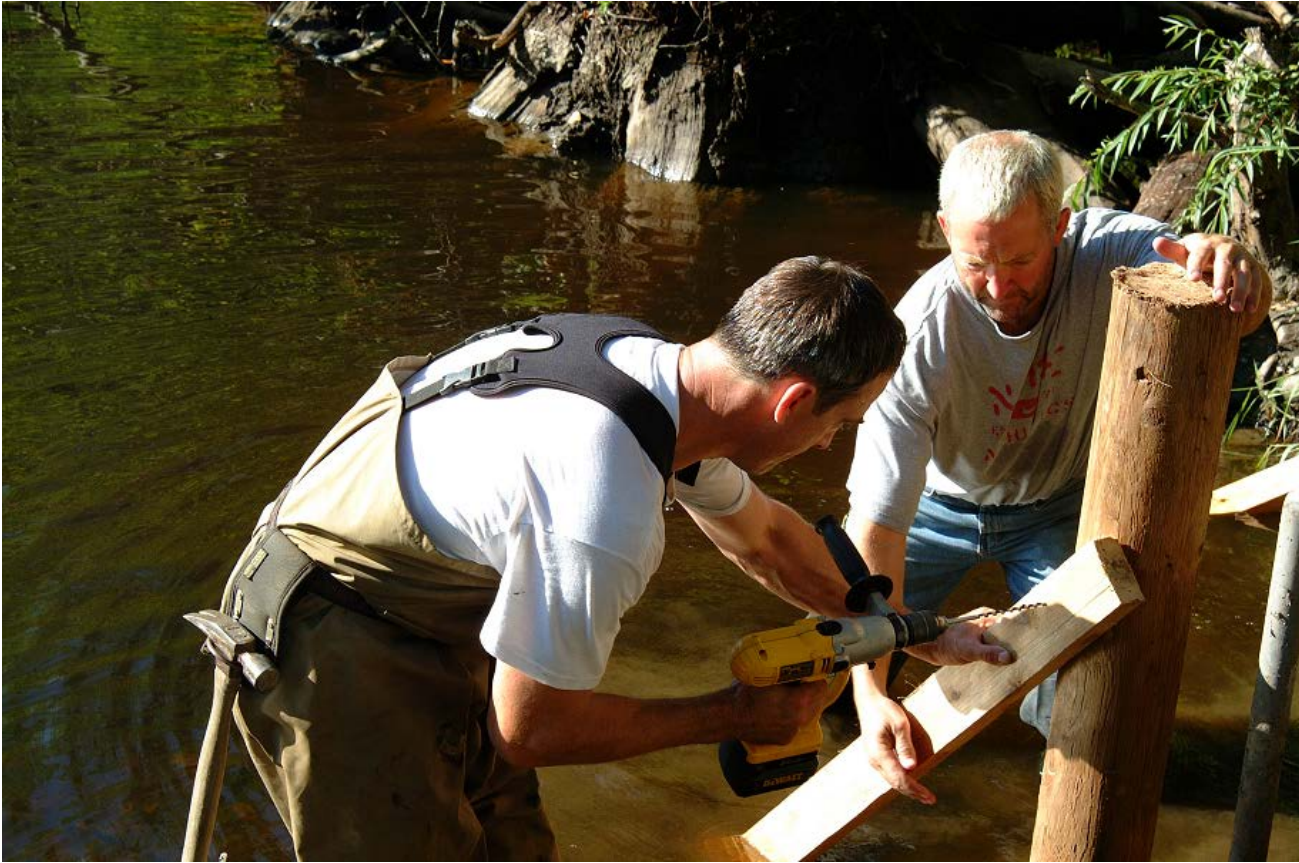
The receiver fence is installed at the mouth of the fish ladder or culvert mouth.

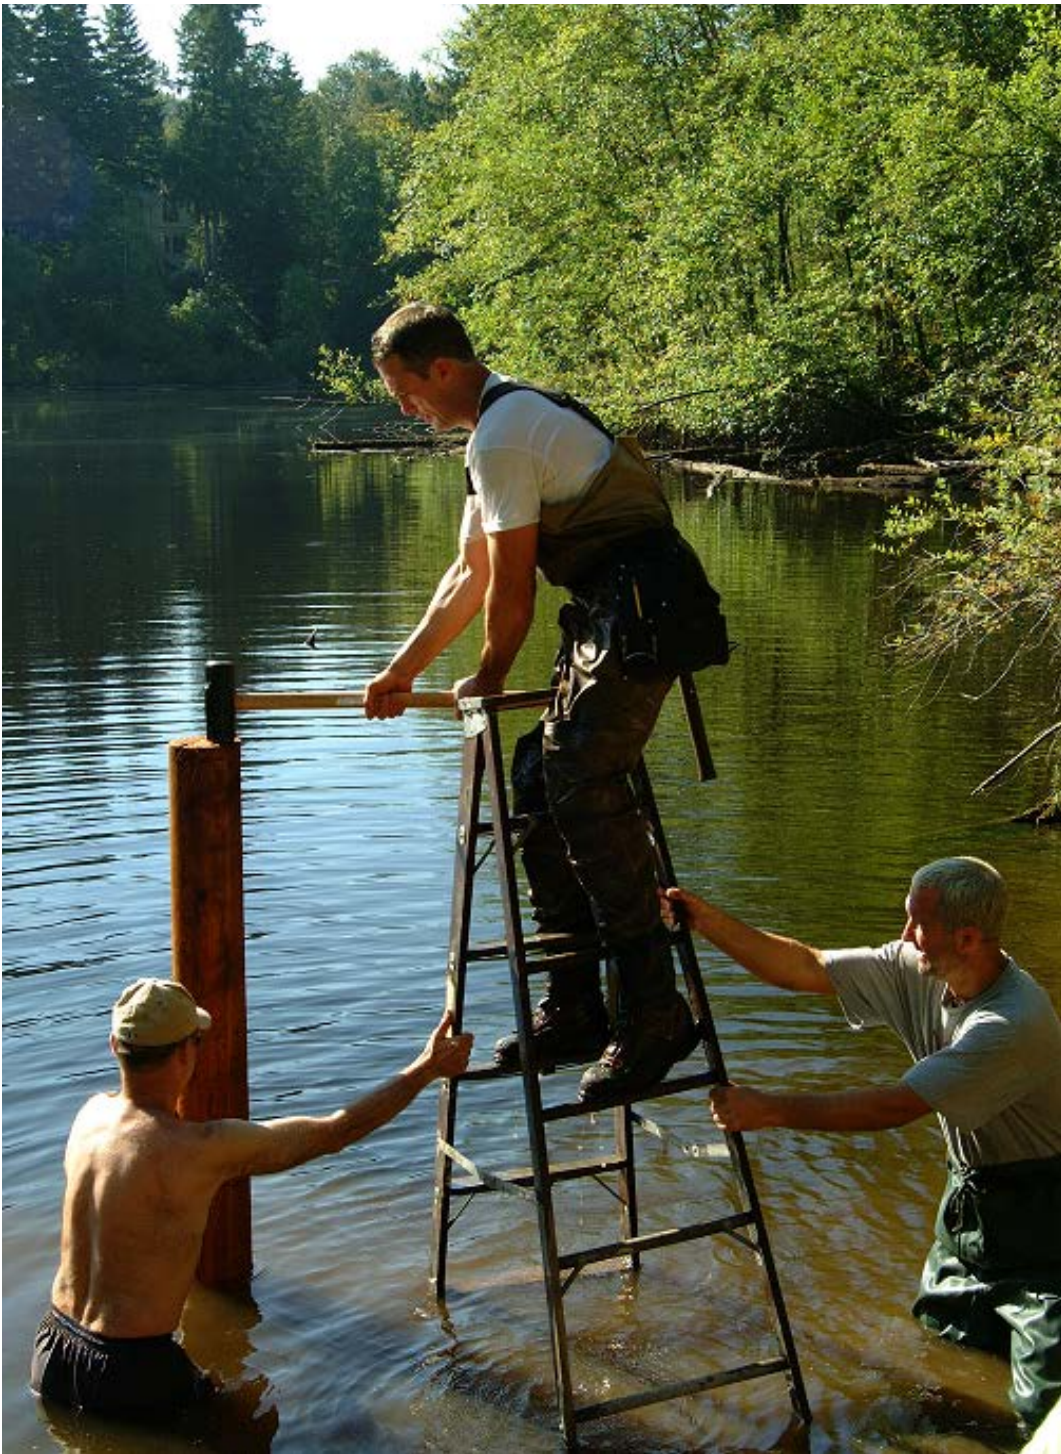
Using a step ladder to pound the corner posts into the substrate with a sledge hammer.

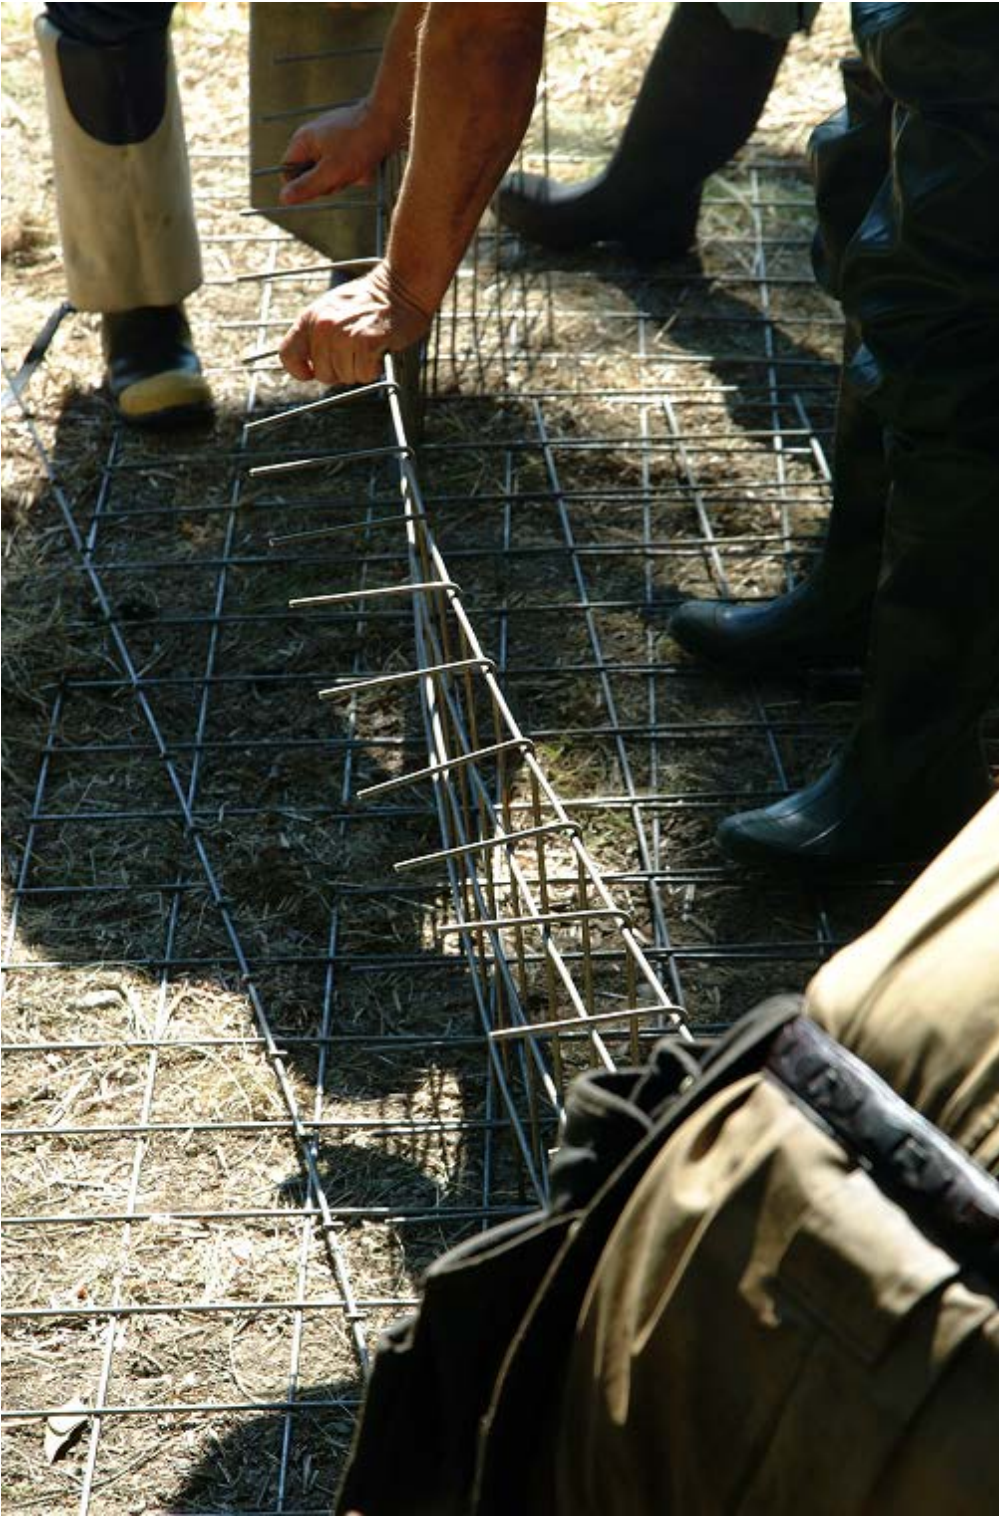
A footing is required along all of the outside edges at the bottom of the receiver fence to prevent beavers from easily digging under the vertical fence and reaching the outlet with branches and debris. The footing is created with a section of the fencing material.

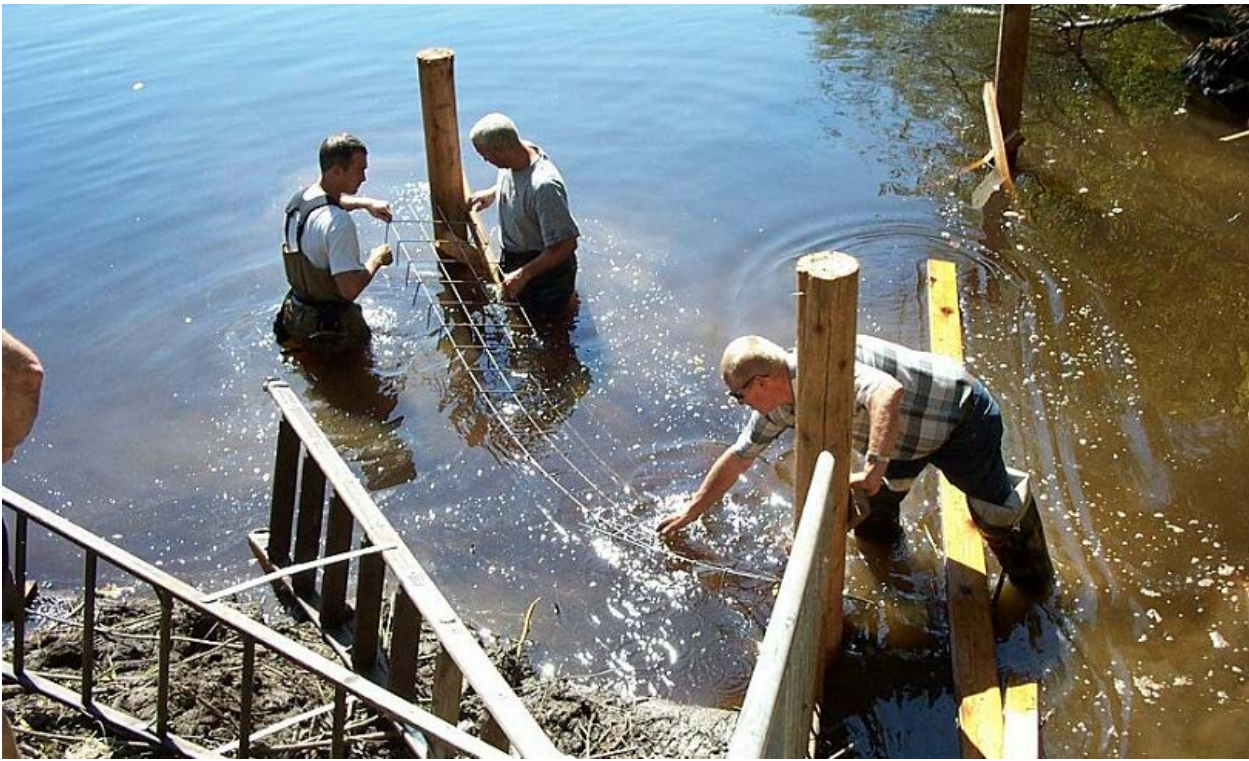
Installing the footing.

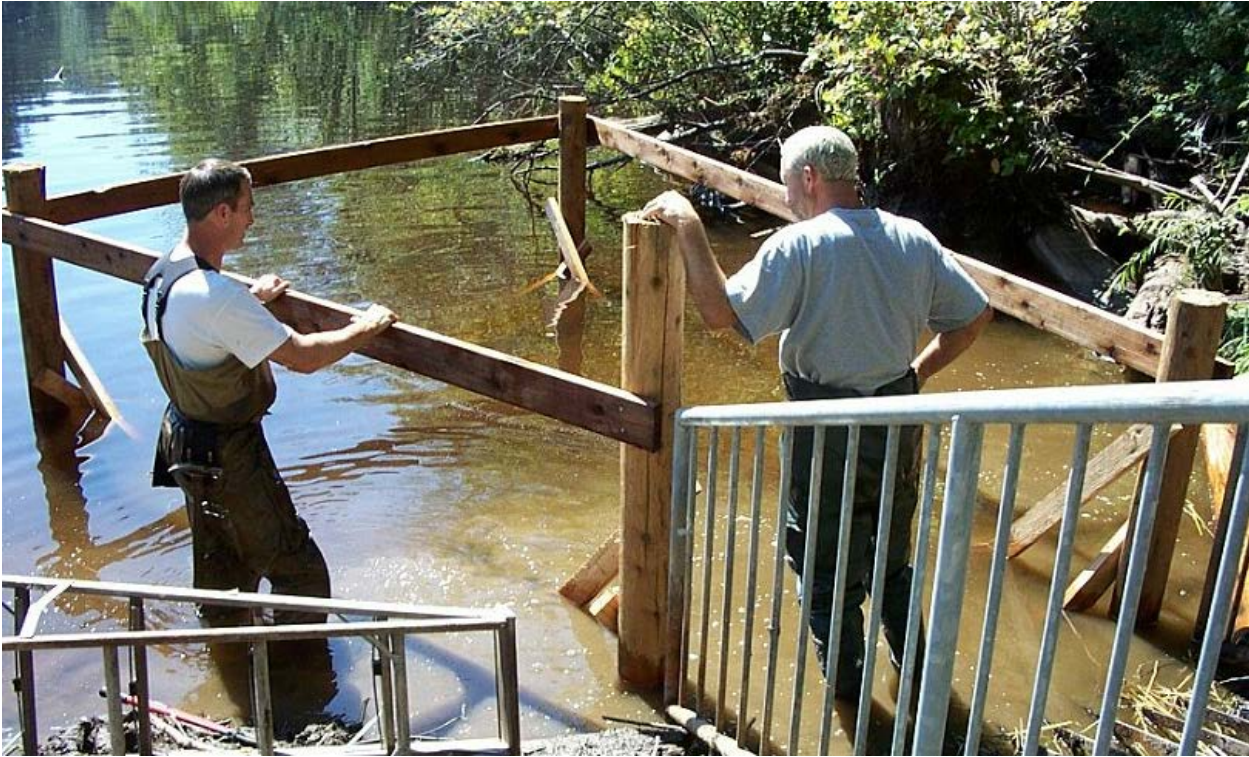
Attaching the stringers to the side posts.

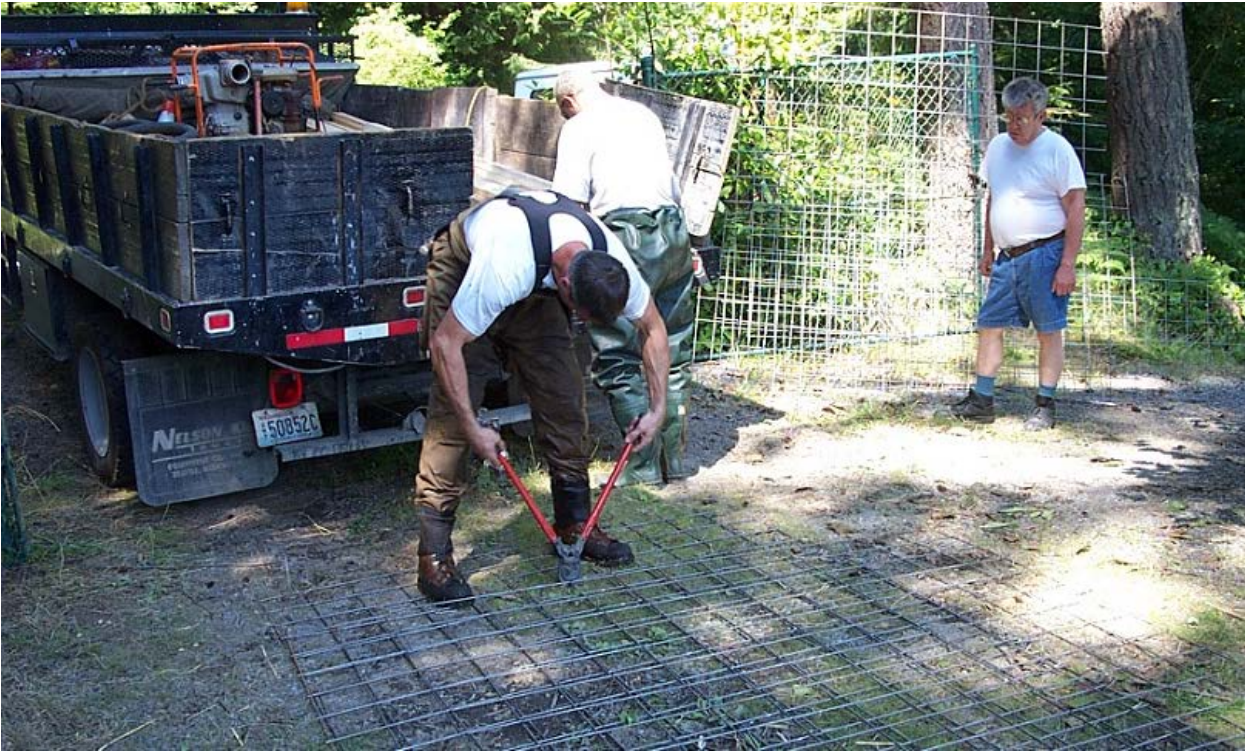
**Cutting the fencing to match the contours of the pond bottom.**

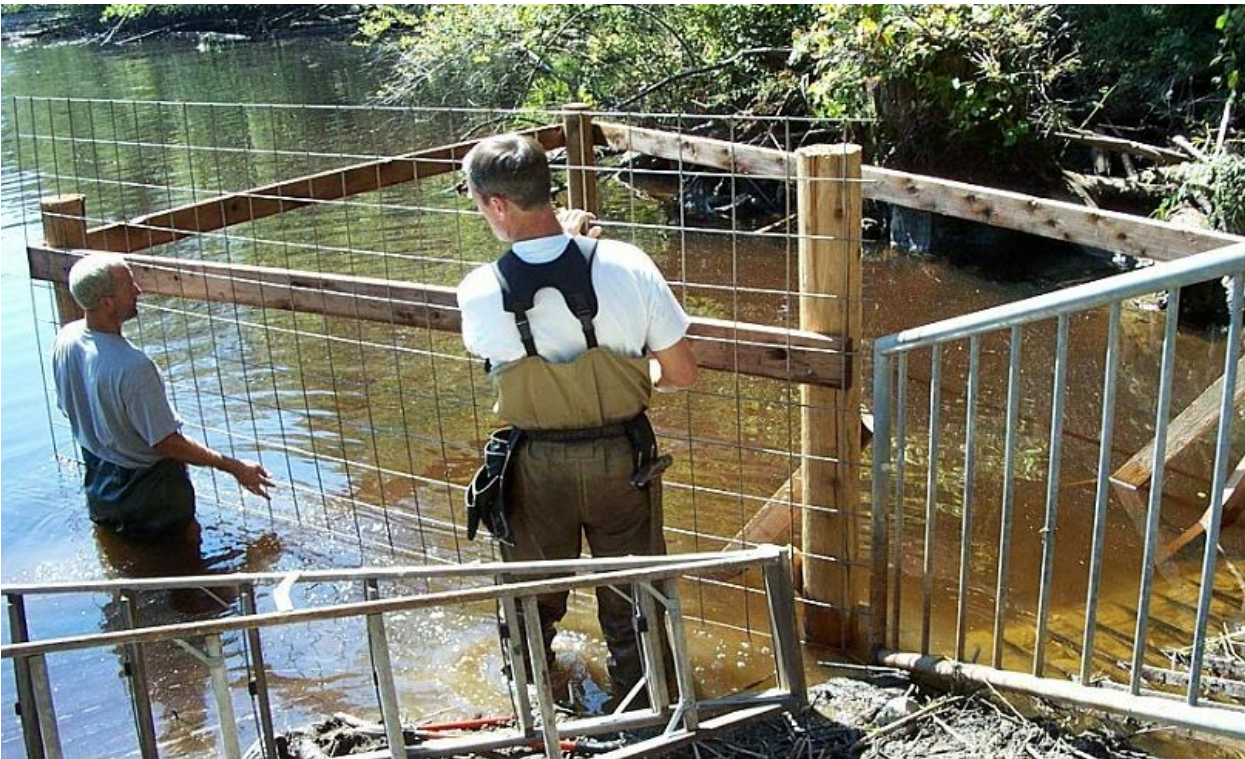
**Attaching the fencing to the sides of the receiver fence.**

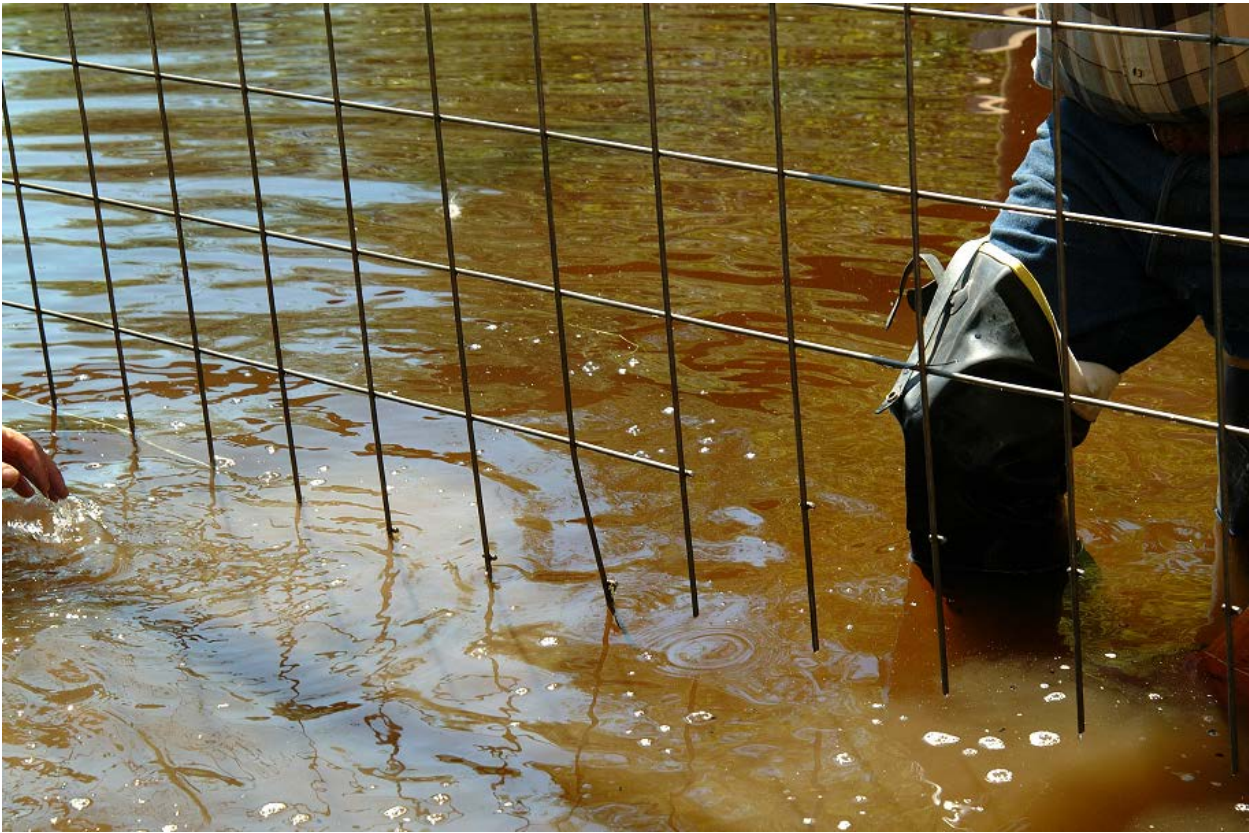
**"Prongs" on the bottom of the fencing to seat into the substrate.**

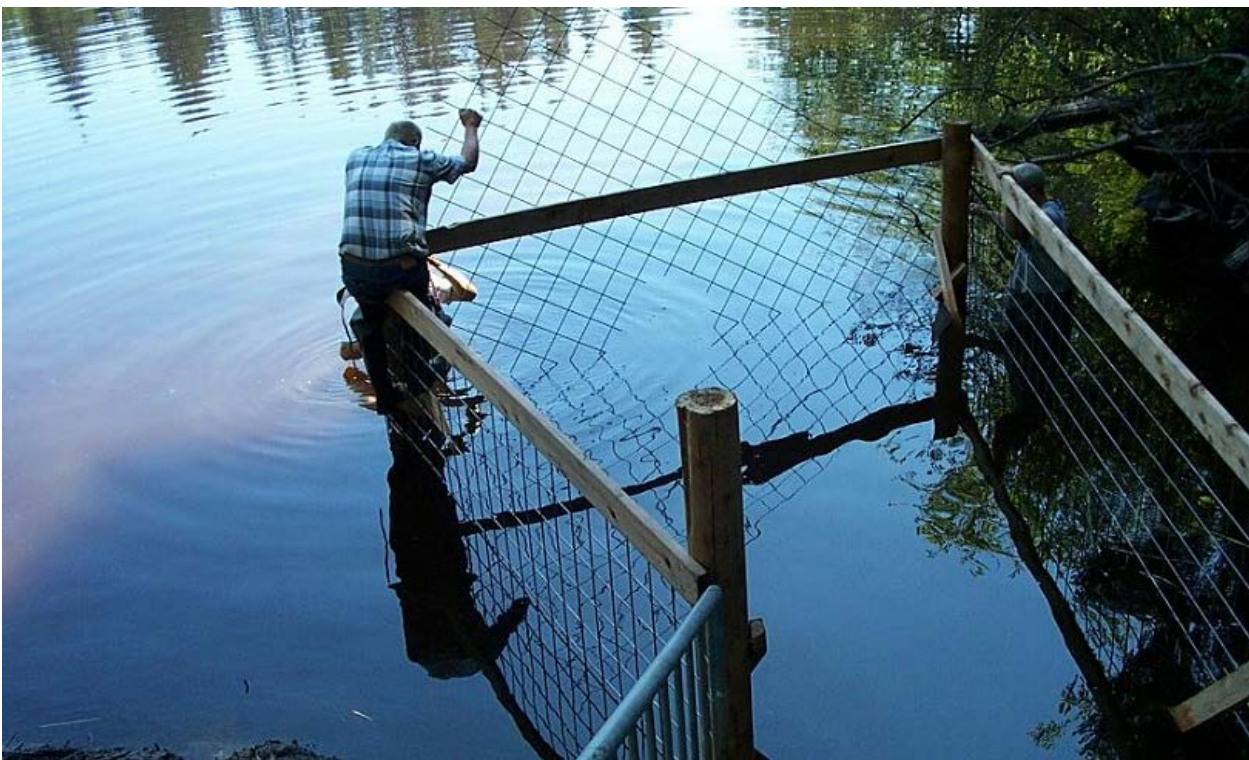
**Last section being lowered into place. Note the hole cut out for the pipe to extend through.**

Because it was not practical to reduce the noise generated by the control structure/fish ladder and the size of the receiver fence was limited by the water depth, it was determined that the beavers might attempt to dam around the receiver fence. A hole was cut in the upstream section of fence to allow a pipe to extend into the pond. If the receiver

fence does become blocked over time, the flow will be maintained through this pipe. A round fence was installed to protect the upstream end of this pipe from beaver activity.

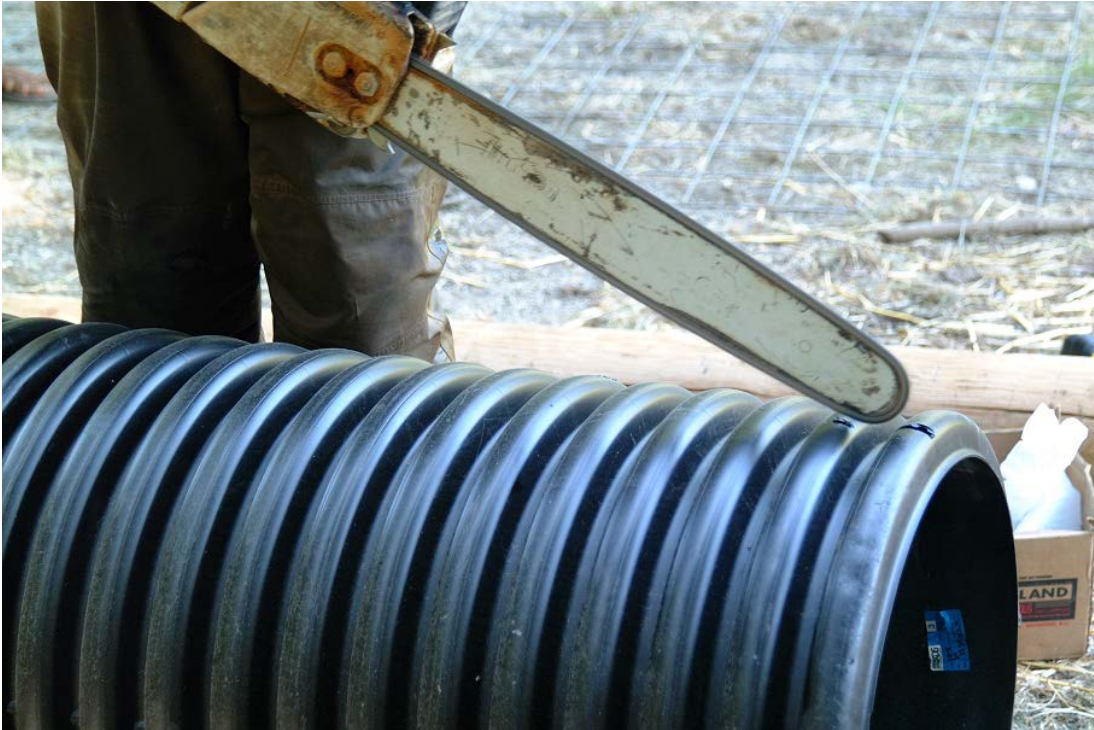
Cutting holes in the pipe to allow trapped air to escape and the pipe to sink.

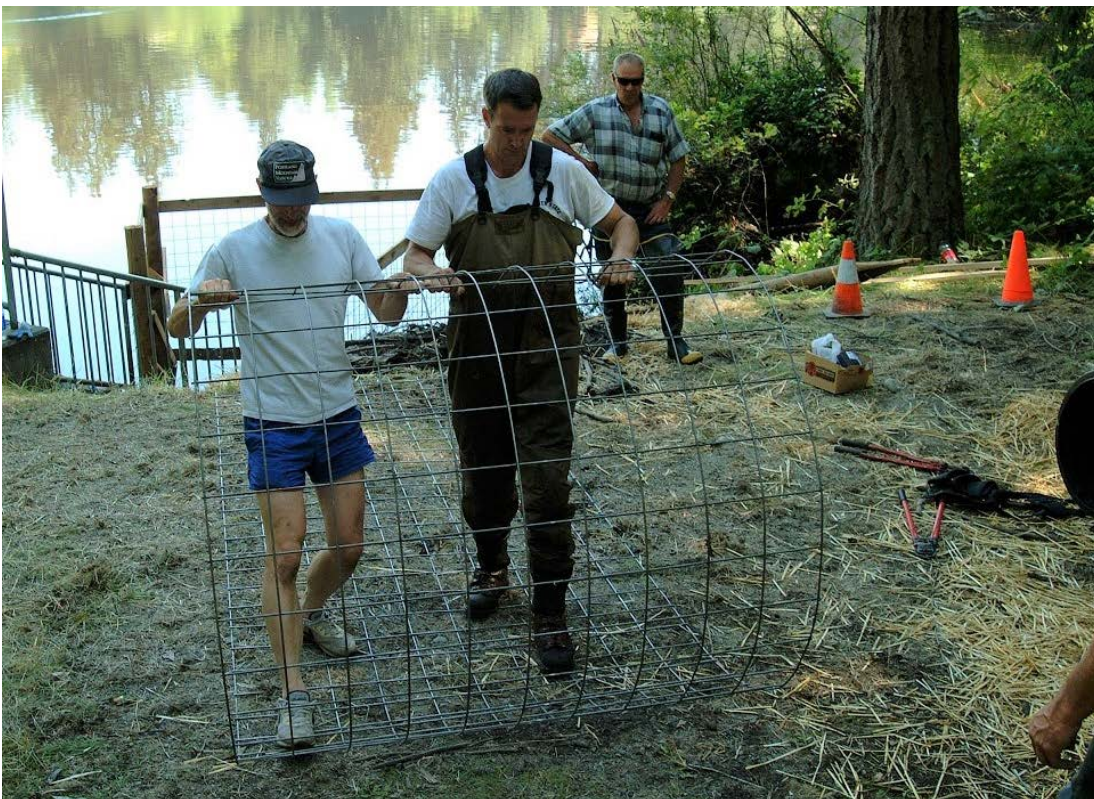
Rolling up fencing for the round fence.

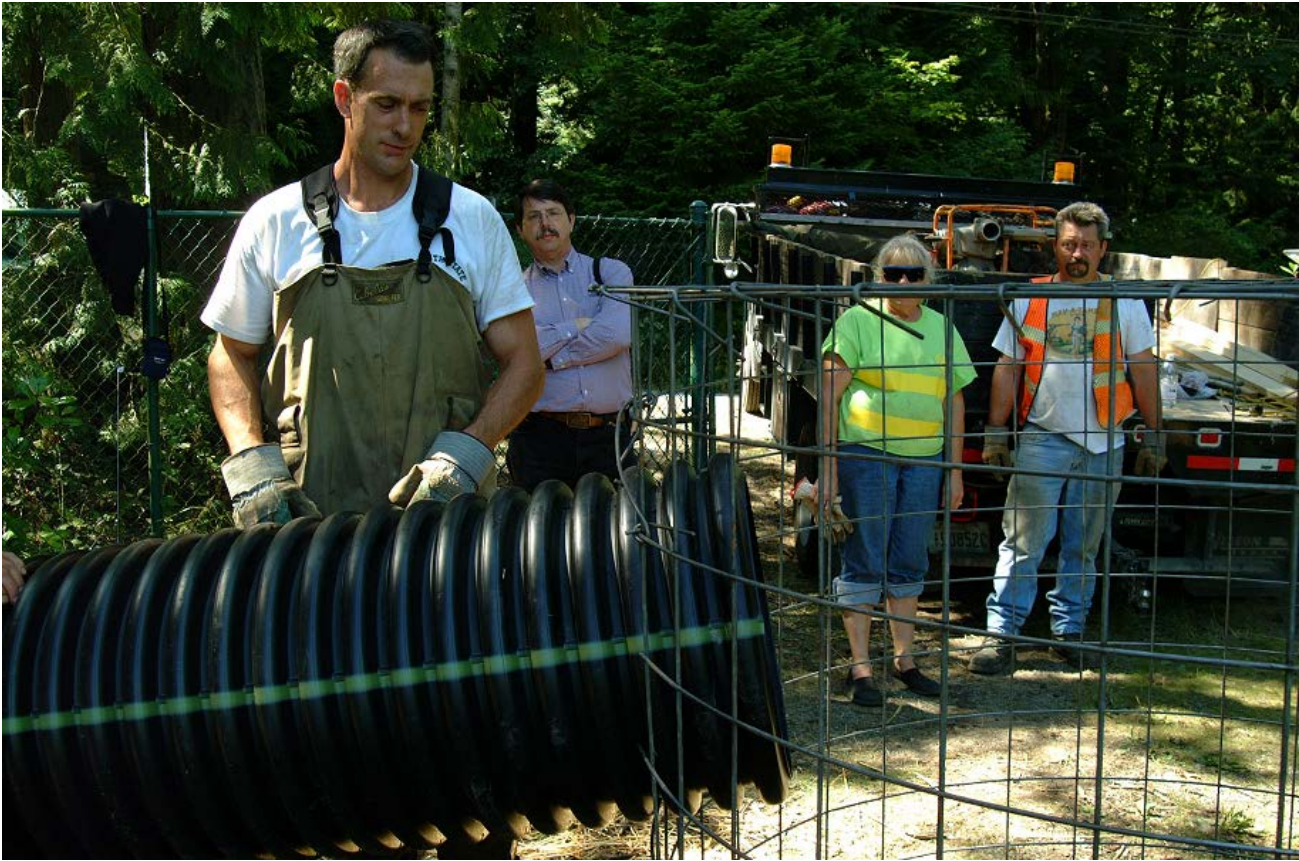
Inserting the pipe into the round fence filter.

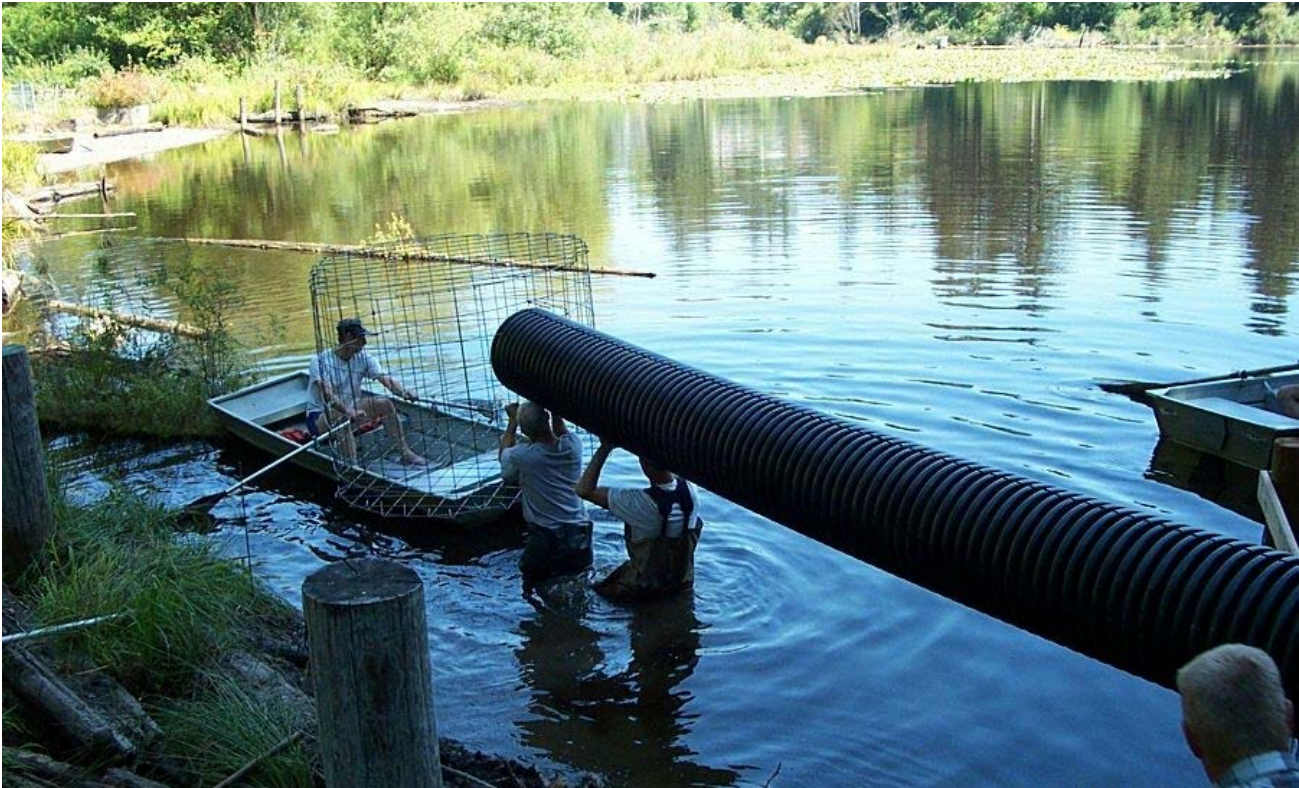
Moving the pipe and round fence out into position.

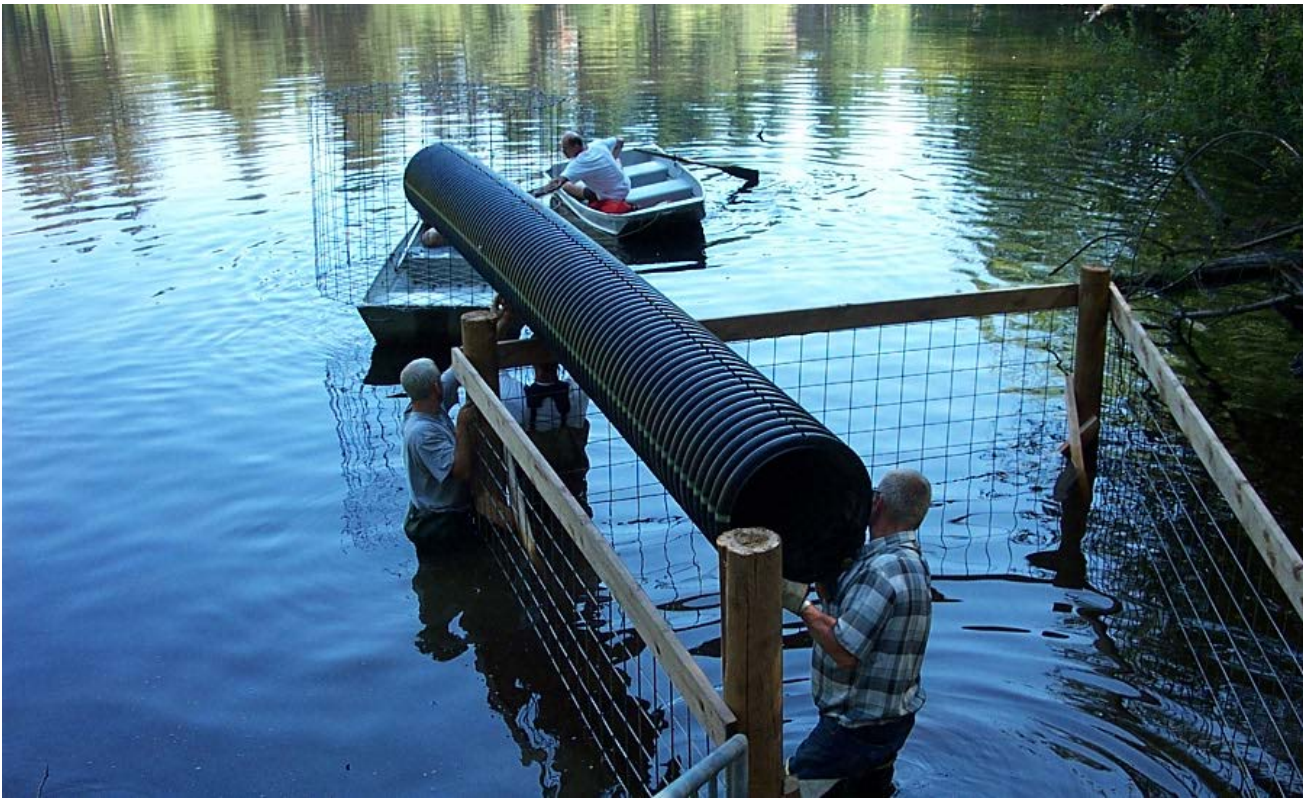
**Moving the pipe into place by the receiver fence.**
