# Building a Beaver Deceiver - Peterson Pond

This narrative presents an example of an engineered solution to living with beavers in King County. In it we describe the design and installation of a “beaver deceiver” at Peterson Pond in King County, Washington.

# Description of the Stormwater Control Facility at Peterson Pond

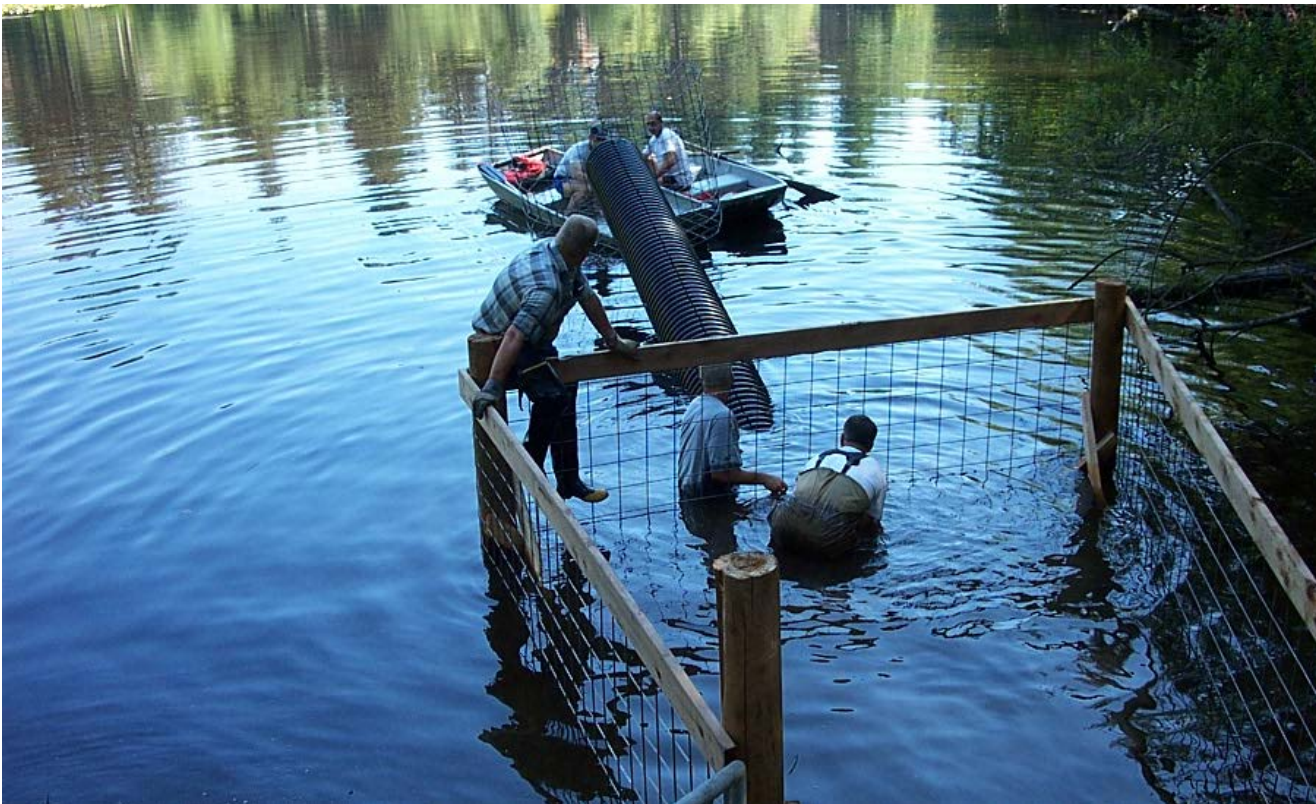
**Peterson Pond dropped off to around 8 to 10 feet in depth shortly past the end of the receiver fence, a small boat was needed to move the round fence into place.**

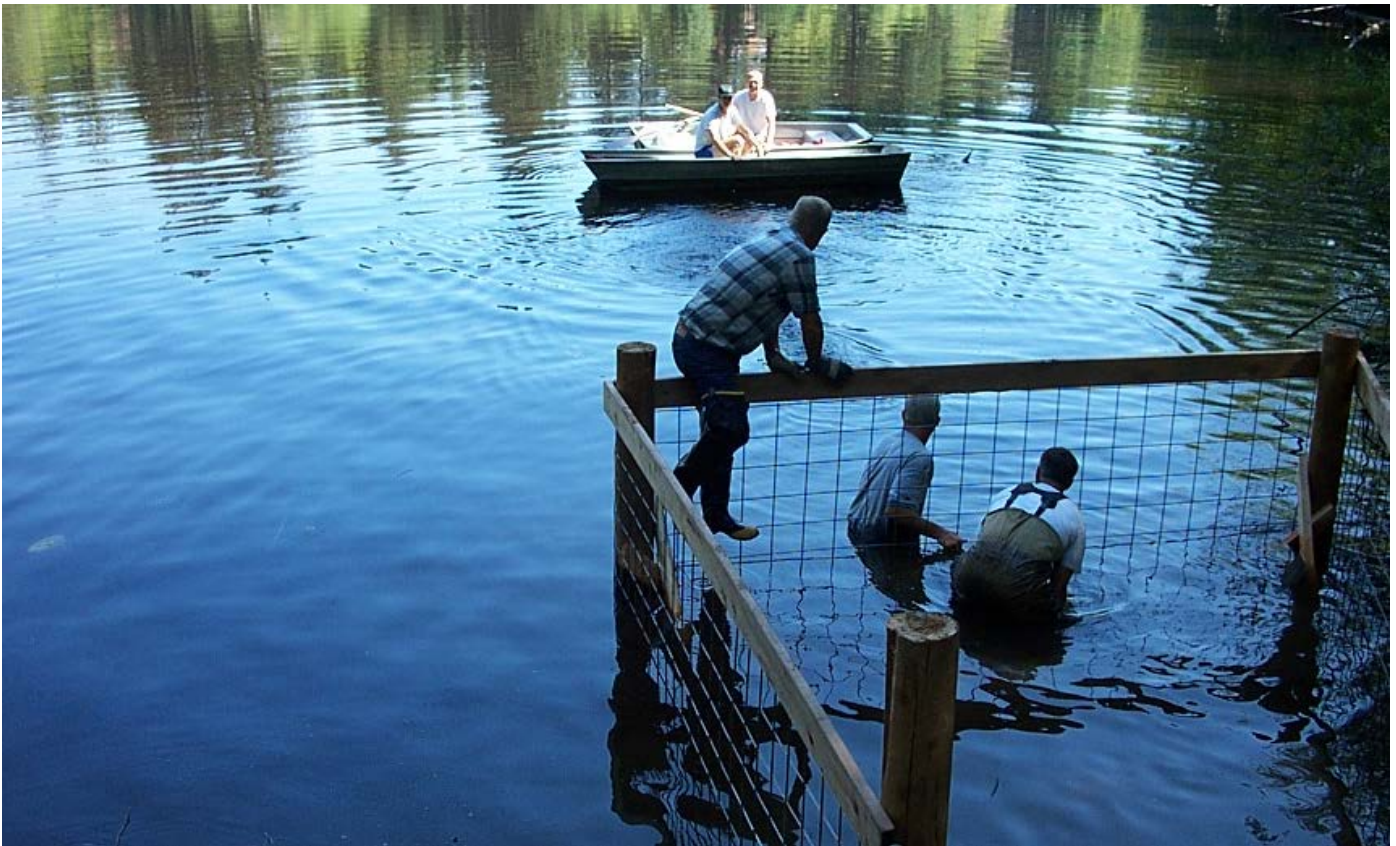
The pipe and round fence are placed on the bottom.

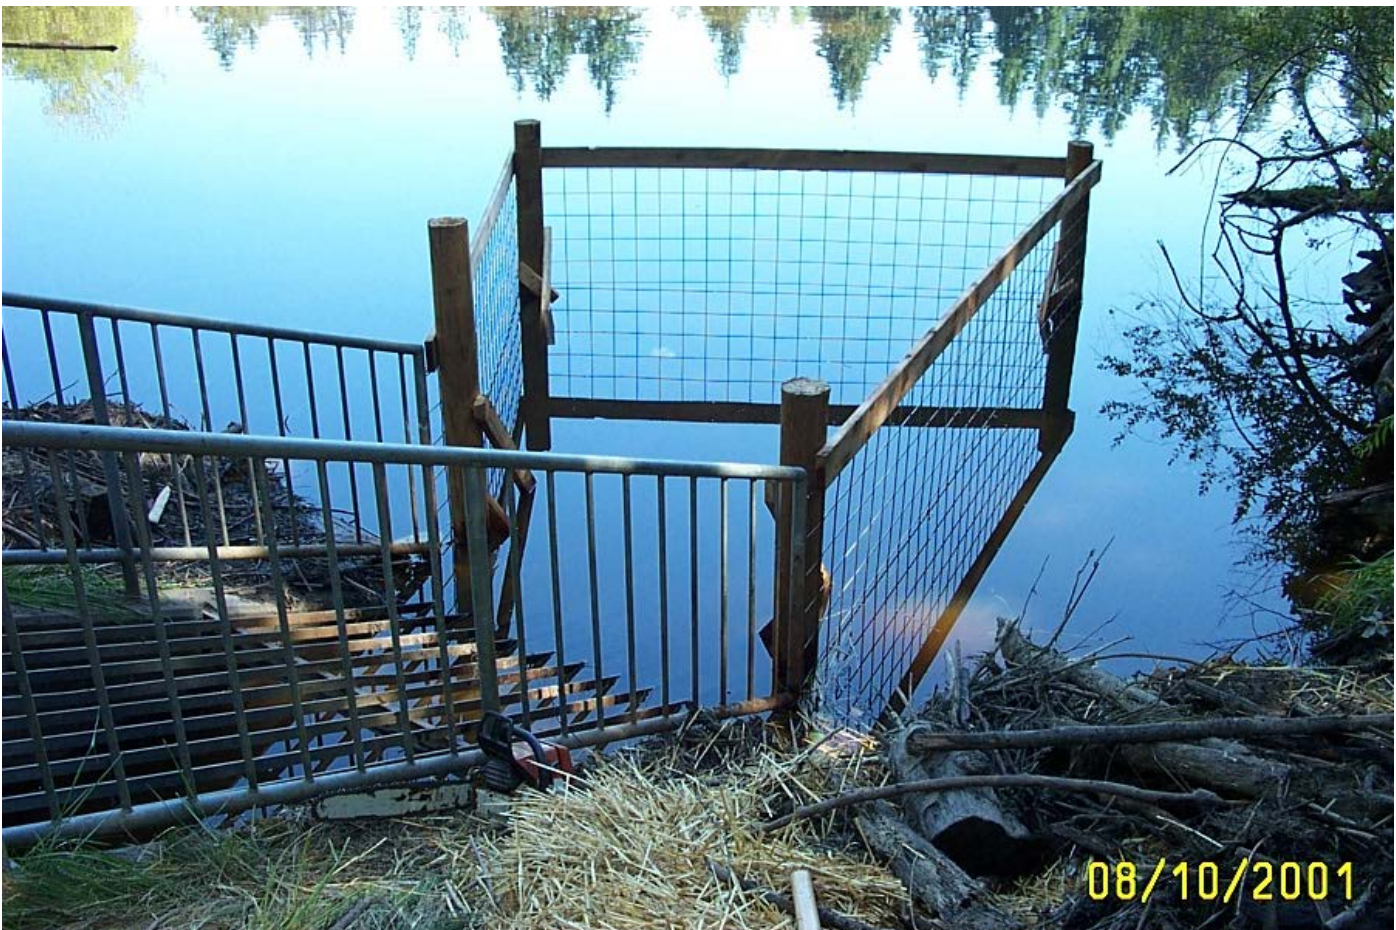
The finished Beaver Deceiver at Peterson Pond!
